TECHNOTE

Recalibrate SmartTouch SVT43 Screen

SmartTouch keypad (P/N: SVT43)

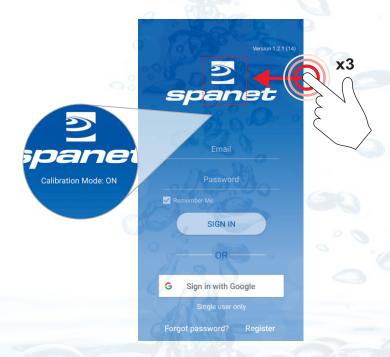
Step 2

Triple tap the Spanet logo to activate light bulb Calibration Mode: ON will appear
